JUNE 2021

DENTAL IMPLANT IDENTIFICATION BASED ON ARTIFICIAL INTELLIGENCE

BY SPOTIMPLANT

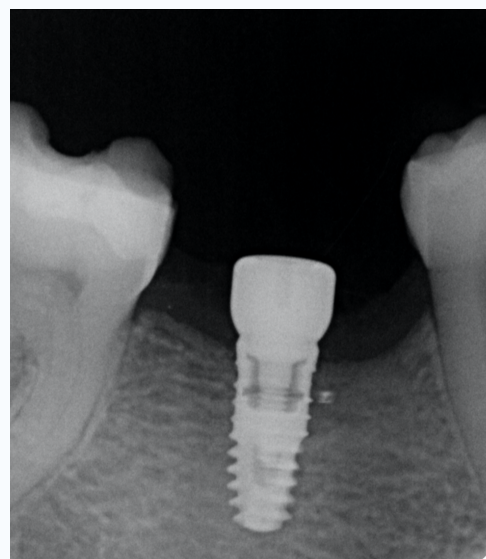
Fig. 1. Orthogonal and clear periapical radiograph of an implant

To be processed properly, the JPEG image must be as orthogonal and clear as possible, target only one implant at a time from head to apex, and be exported directly from the imaging software, as shown in Figure 1. A few questions are then asked to collect additional information such as: country, year of implantation, etc.

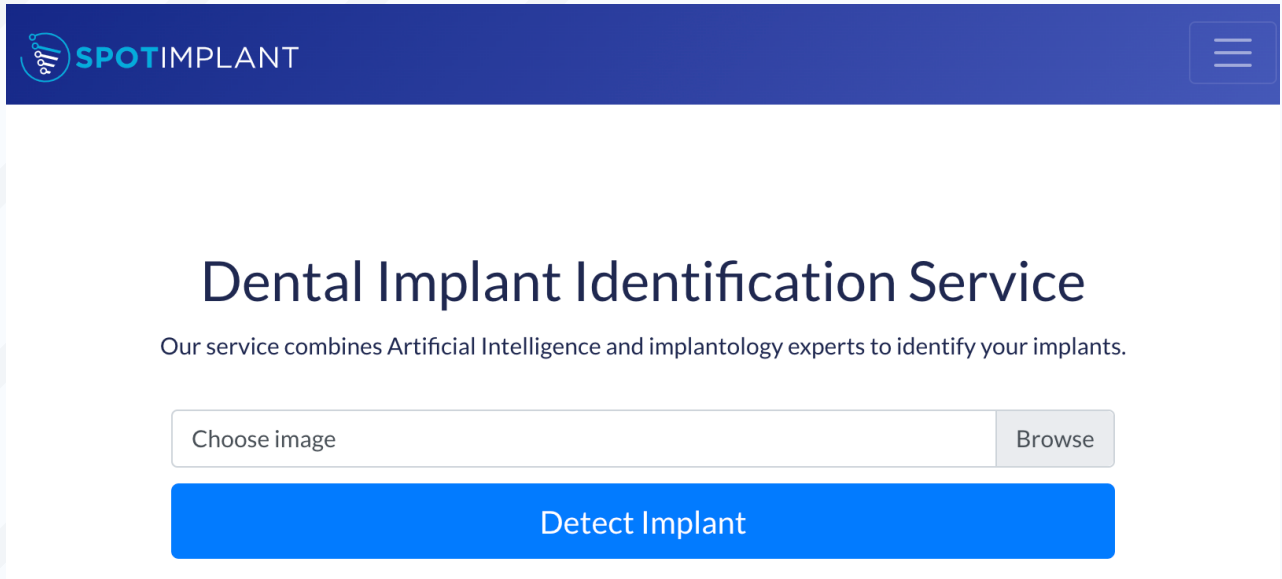
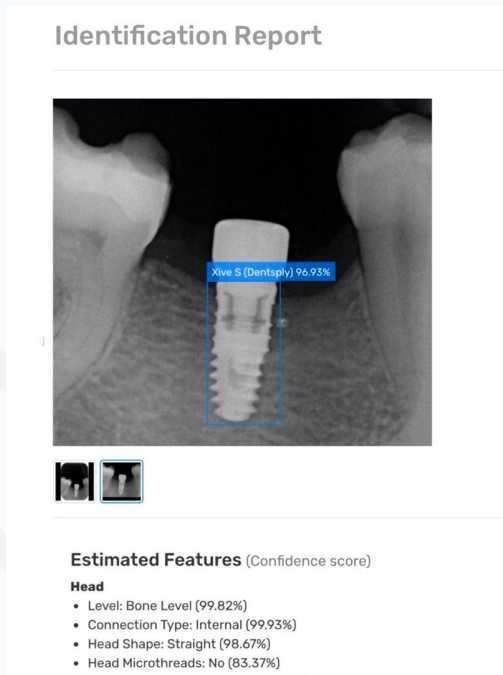
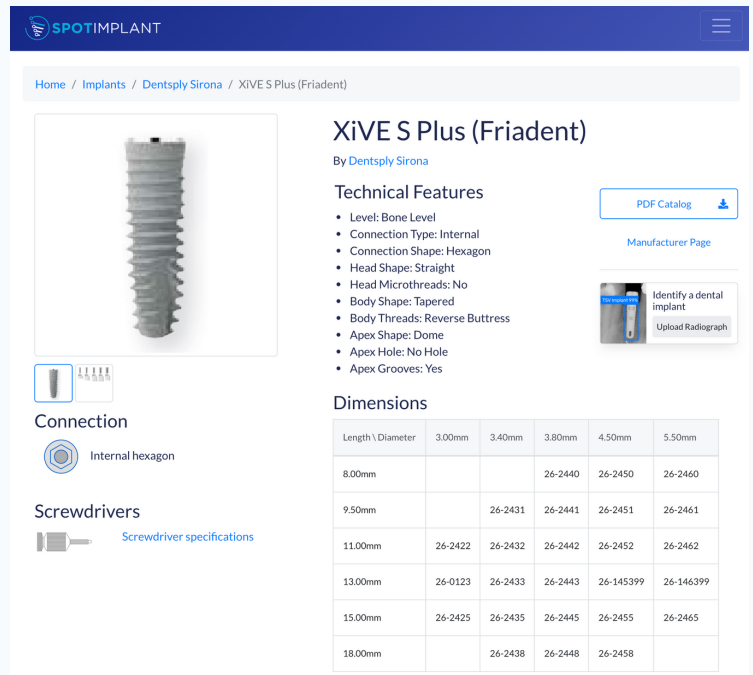
Figs. 2, 3 & 4: Results given by the Spotimplant platform after implant identification

The identification report was returned to the dentist within 24 hours. This report is performed by a hybrid system composed of artificial intelligence and controlled by implantology experts (Figs. 2, 3, 4).

The identification report includes a list of the most likely implant alternatives, all based on probability scores. This allowed the dentist to make a decision on the final identification, review the technical specifications and finally order the right components to start the prosthetic treatment, and finally initiate the following specific steps:

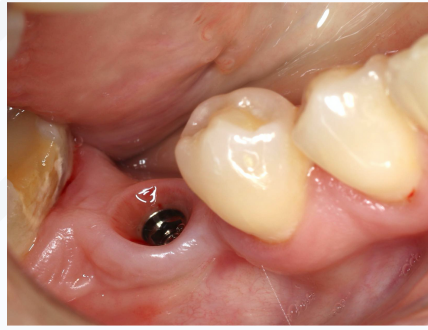
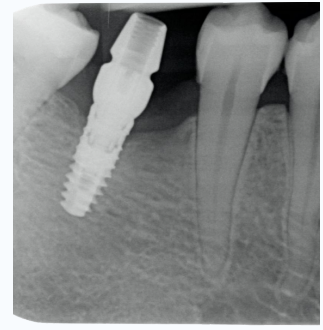
Figs. 5 & 6: Screwing of the impression transfer and verification

First, the impression transfer was attached and a radiograph was taken to verify the fit (Figs. 5 & 6).

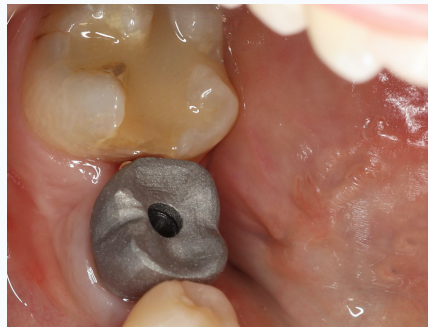
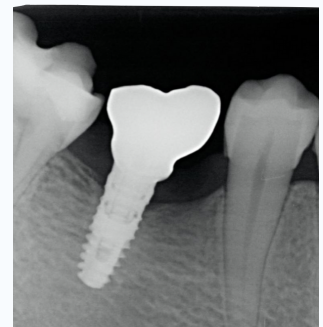
Figs. 7 & 8: Try-in the abutment and metal framework

Then, the impression was taken and the abutment along with the metal framework were tried in (Figs. 7 & 8).

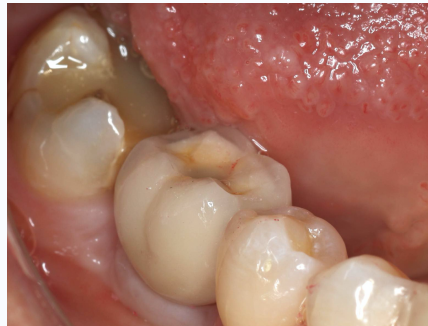
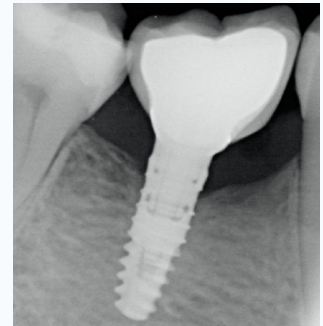
Figs. 8 & 9: Crown placement and adjustment of the occlusion

Once set, the shade of the adjacent teeth was taken into account to create the crown of the implant and adjust the occlusion (Figs. 8 & 9).

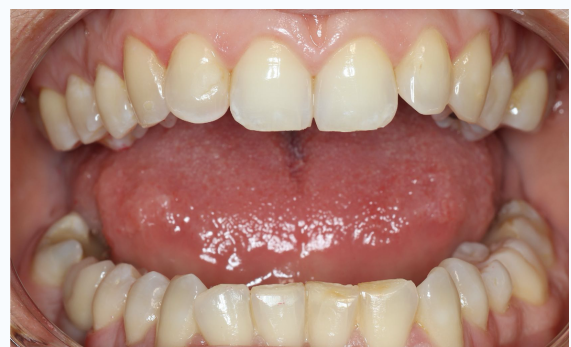
Fig. 10: Final result

Spotimplant's AI-based identification tool was used to identify implant references and determine technical specifications. With this valuable information, the prosthetic restoration could be planned and the compatible components ordered. This allowed the treatment to be carried out smoothly, with a satisfactory outcome (Fig. 10).
